FAIRFIELD UNIVERSITY | FAIRFIELD, CT

Fairfield University Recreation Center

CASE STUDY

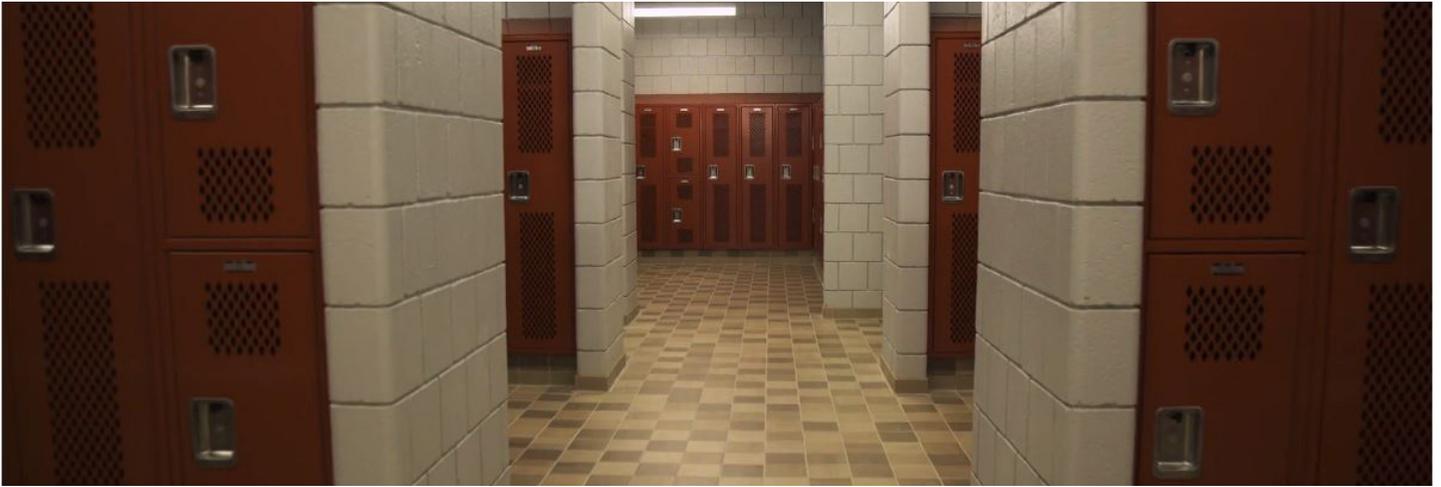
FAIRFIELD UNIVERSITY RECREATION CENTER | LOCKER ROOMS
